THERMAL PHASE

REBUILDING THERMAL PHASE SHOCKS

Replacement Cylinder Rod Assemblies for 1974 thermal phase shock absorbers are now available. Refer to Motorcycle News Bulletin No. 317 for installation procedure.

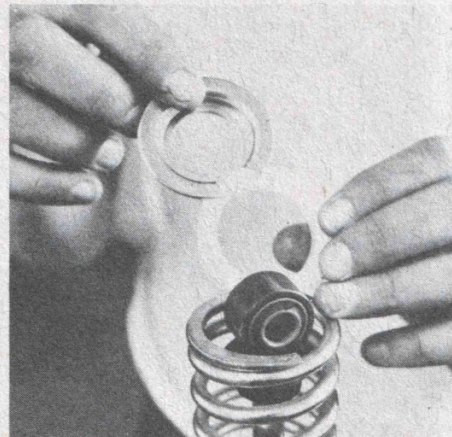
Compress spring and remove spring clip. Remove spring.

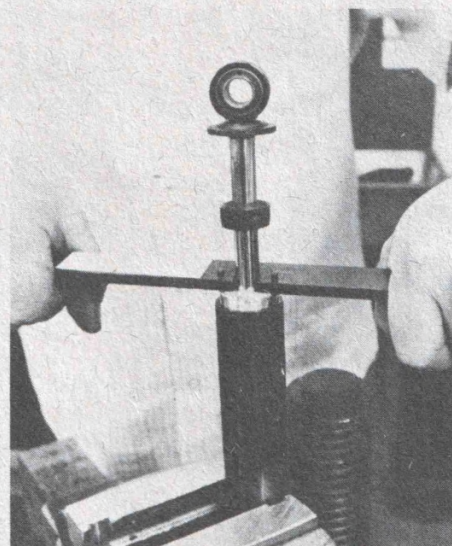
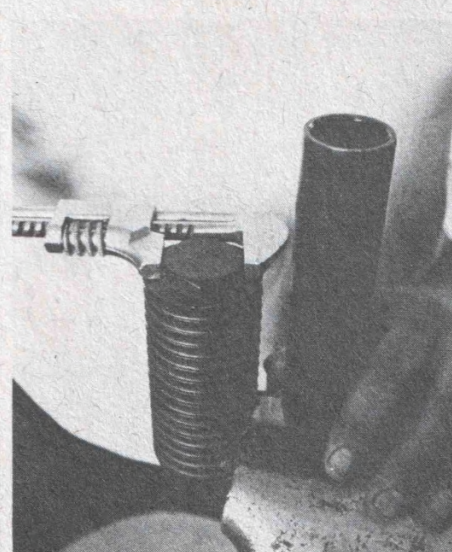
Remove caps. Carefully pump out shock fluid.

NOTE: Punch marks and spanner holes in piston rod nut. Clean out extruded metal between rod nut and cylinder housing. Remove nut.

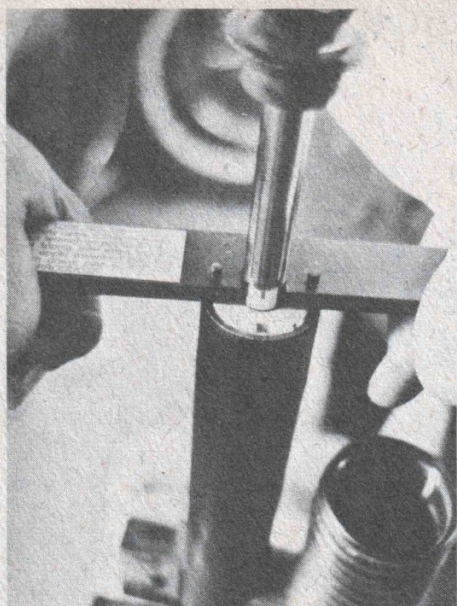
NOTE: A spanner can be manufactured from a piece of $\frac{1}{4}$ " x $1\frac{1}{2}$ " steel strap. Cut a notch to clear piston rod. Drill a hole on each side to align with rod nut holes. Press-fit dowel pins of suitable O.D. into holes in strap.

An alternate method is to drive nut off using a punch in the nut holes. This method may damage the cylinder housing. Use extreme care.

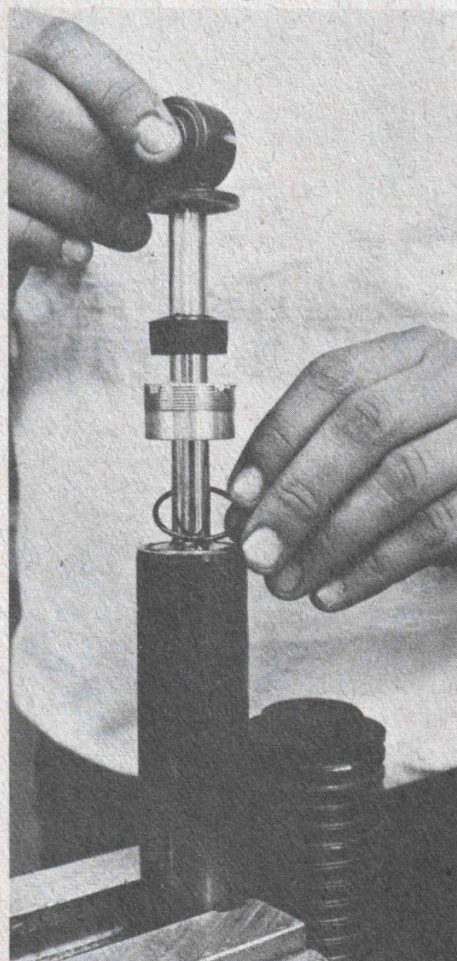
With nut unscrewed, remove and discard piston rod assembly (Fig. 2).

CAUTION: Do not compress piston rod assembly. With no seal on piston, any remaining shock fluid will escape under pressure.

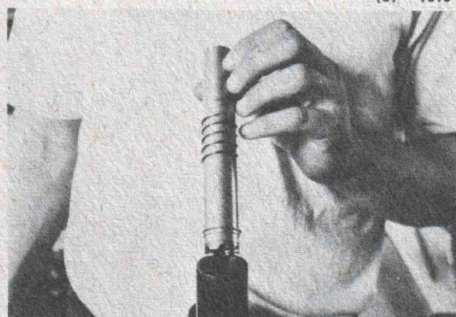
Remove and discard cylinder. Wash housing thoroughly in clean solvent.

CAUTION: During washing and reassembly, take extreme care to see that all parts are thoroughly cleaned. The smallest foreign particle within the assembly can impair damping action by blocking the damping jets.

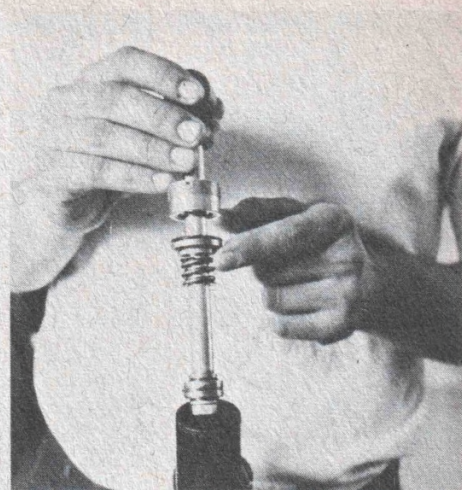
Install replacement cylinder. Note location of coil spring around cylinder. This is an anti-foaming device and must be in place at the approximate center of cylinder.

Install replacement piston rod assembly. Check location of O-ring at base of rod nut. Piston seal is incorporated within rod nut.

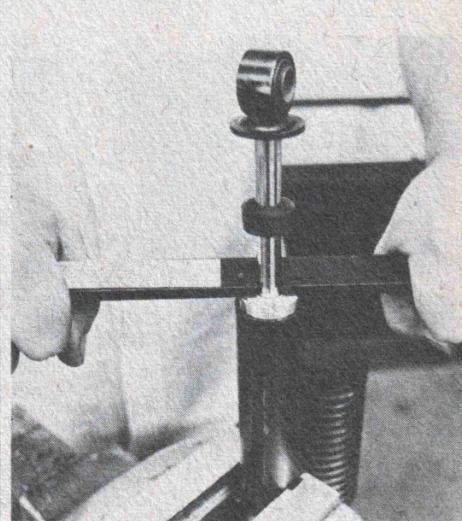
Torque piston rod nut (new type has flats for wrench) to 80-100 in/lbs. Stake to prevent loosening (Fig. 1).

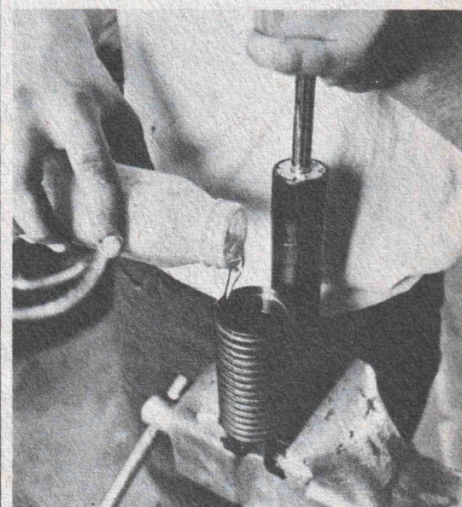
Add 175cc (6.0 oz.) shock fluid to reservoir. Install reservoir cap bolt. Torque to 175-200 in/lbs.
